December 12, 2015
&
December 16, 2015

Oxnard Wastewater Treatment Plant

6001 SOUTH PERKINS ROAD
OXNARD, CALIFORNIA

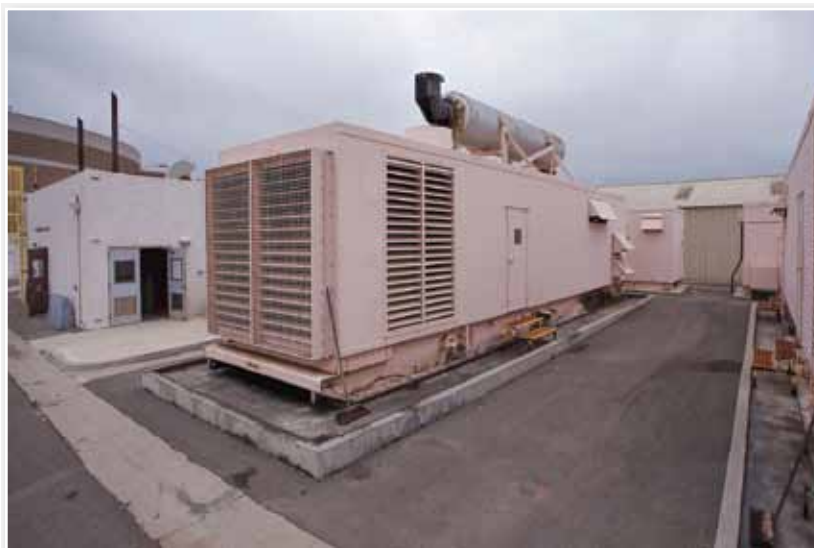
1. Emergency Standby Generators:

Recently, the emergency standby generators failed to start automatically after a power outage. The standby generators are a challenge to maintain because it is often difficult to find parts that are 50 years old.

Install two new standby generators for full plant power back up to meet regulatory reliability requirements.

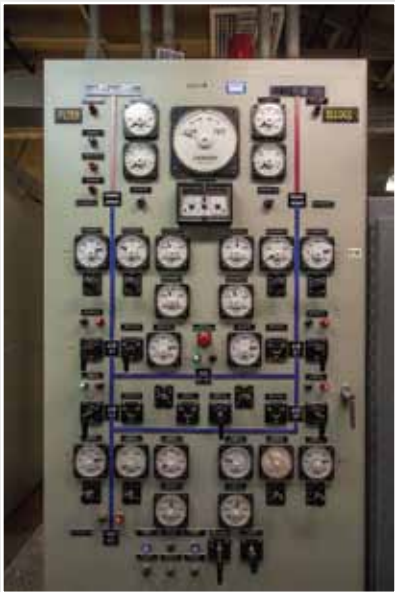
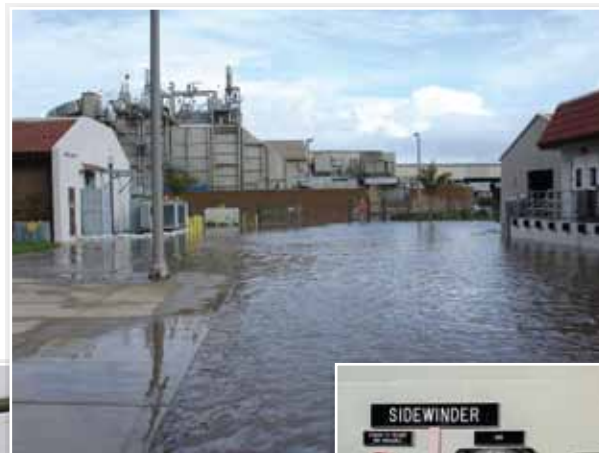
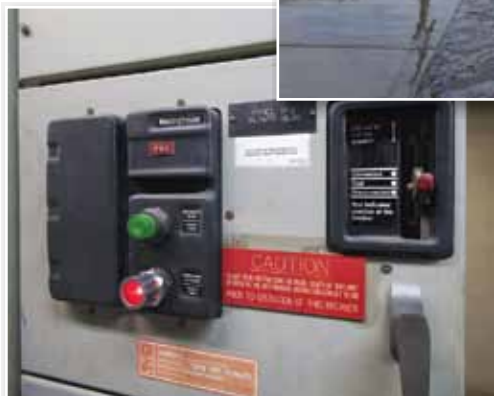
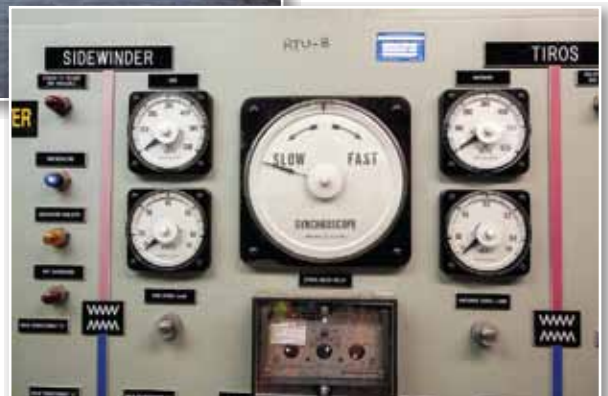
2. Main Switchgear Building:

The Main Switchgear Building does not meet current earthquake building standards. The equipment is antiquated and there is the potential for it to arc and electrocute someone standing nearby. The building is also subject to flooding which can pose additional electrical hazards.

Replace new Main Switchgear Building and upgrade electrical equipment for safety and performance requirements.

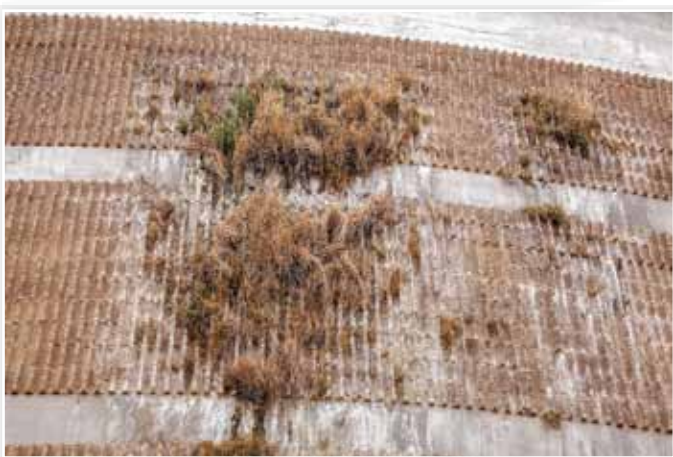
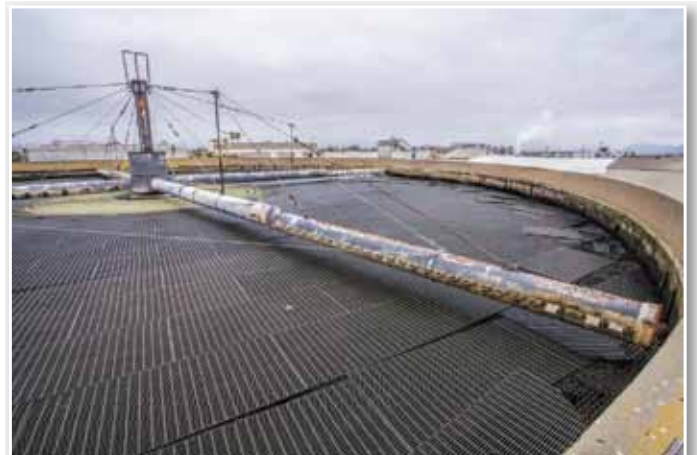
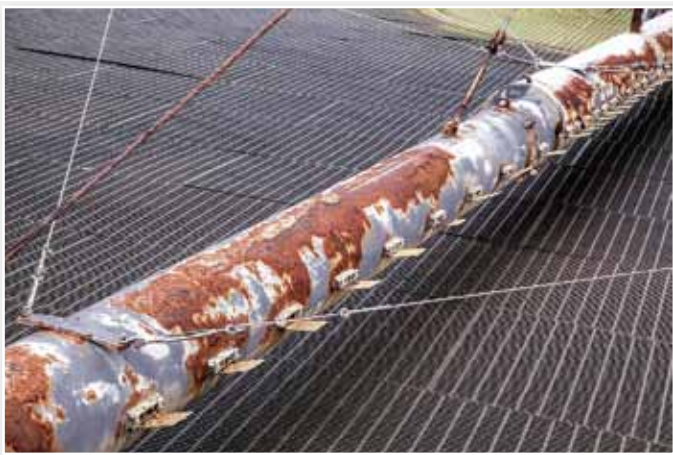
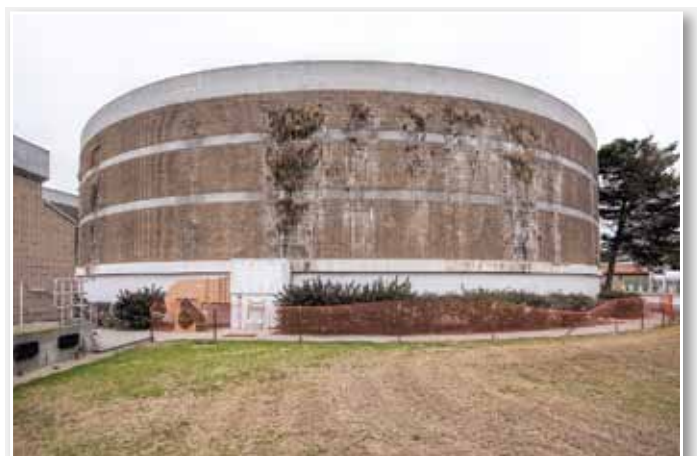
3. Biotowers:

The biotowers are failing due to: cracking, staining, the leaking of raw wastewater, and deteriorating concrete masonry. The loss of concrete surface is significant in some areas. Vegetation feeding on the wastewater can be found growing through cracks in the walls.

Decommission and demolish biotowers for safety and performance reasons.

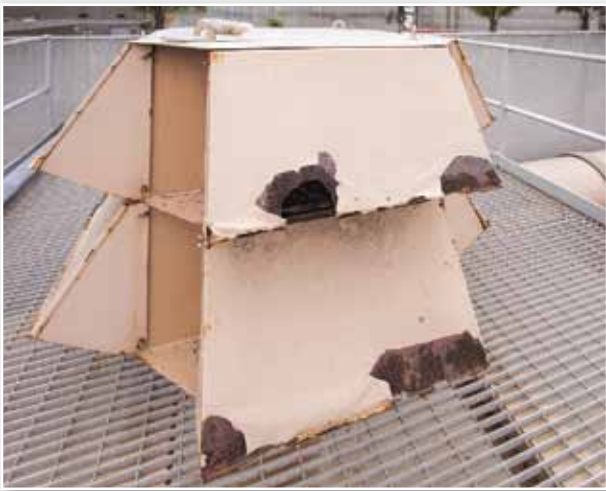
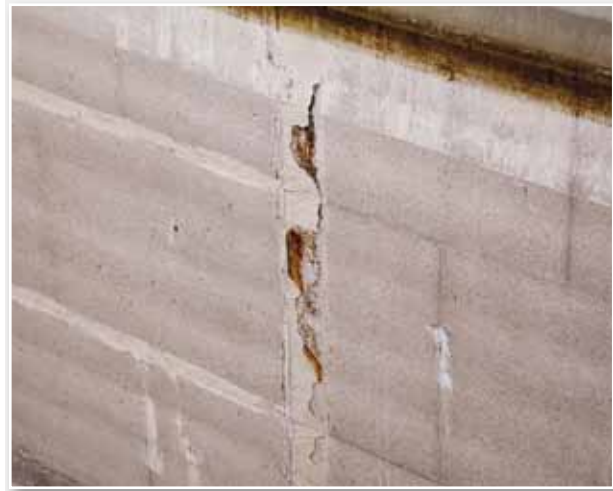
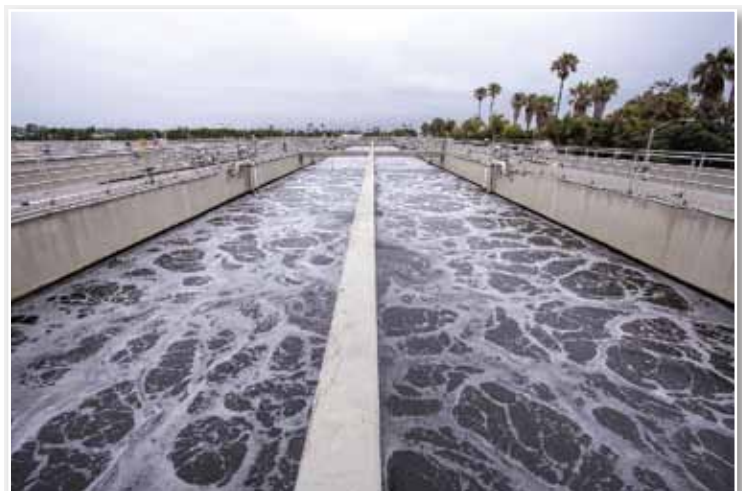
4. Aeration Basins:

Air diffusers, blowers, and air distribution piping are more than 25 years old and many parts are showing the effects of age. The computerized control system will not operate in automatic mode, which increases the chance for errors. The structures are not adequately reinforced to protect against earthquakes.

New SCADA system, blowers, diffusers, and air distribution piping. Seismic retrofit of existing structures that includes tank resurfacing.

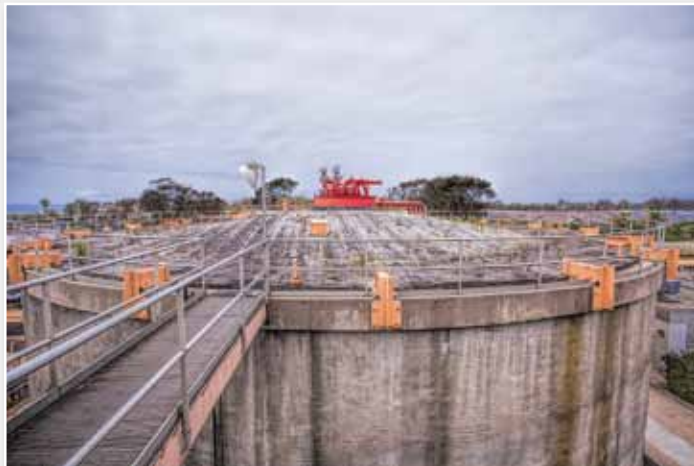
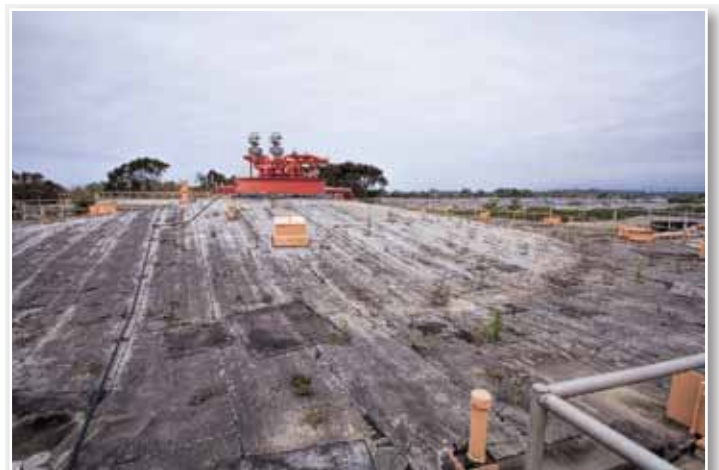
5. Anaerobic Digesters:

Digester #2 has not been operational since 2012 due to the failure of its roof. Because of this digesters #1 and #3 cannot be taken out of service for routine maintenance, which is causing them to deteriorate more rapidly. Heat exchangers, gas tubing, and recirculation pumps are more than 25 years old and will need replacement soon.

Phased replacement of existing digesters and ancillary equipment to meet regulatory, reliability, and performance requirements.

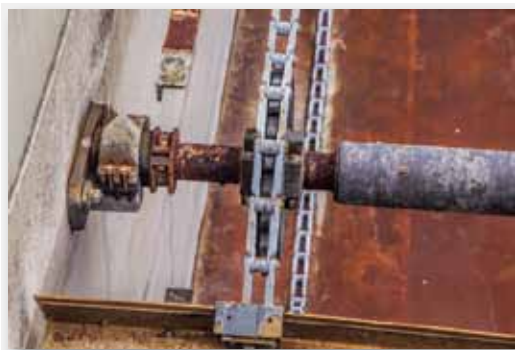
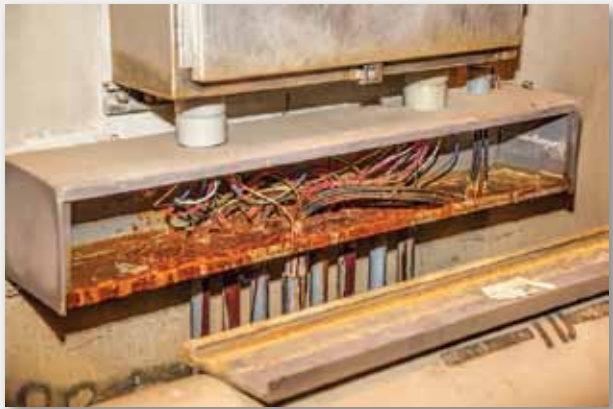
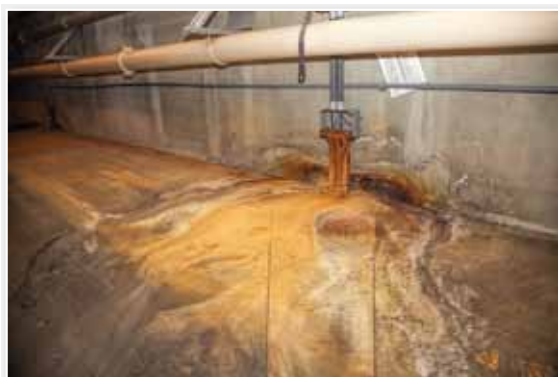
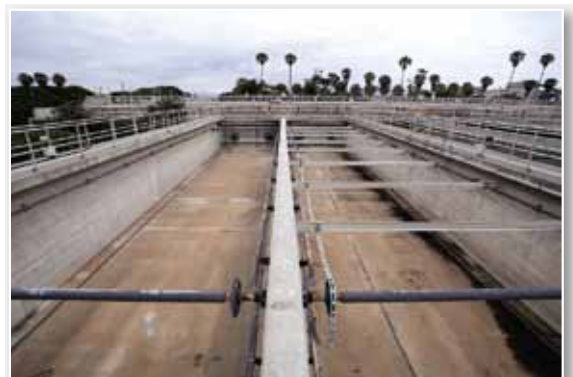
6. Secondary Sedimentation Tanks and Flow Equalization Basins:

Sedimentation tanks which collect solids, are more than 25 years old and many are suffering from the effects of corrosion. The flow equalization basin and secondary sedimentation tanks have also deteriorated to the point where they may not withstand an earthquake.

Concrete repair for both structures. New chain and flight mechanisms and a new coat of paint for the sedimentation tanks. Seismic reinforcement of the flow equalization basin walls.

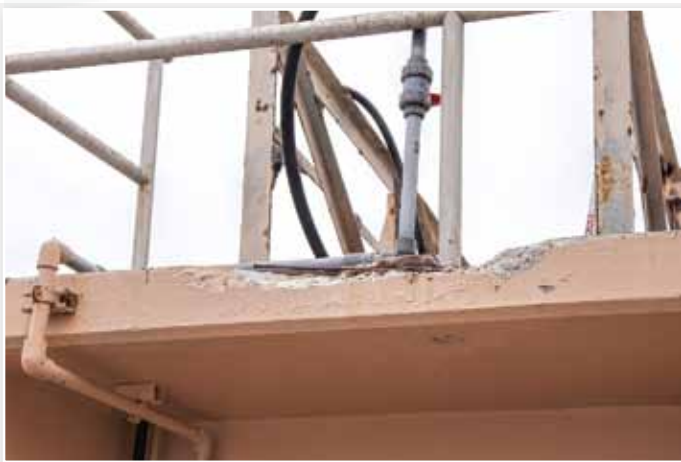
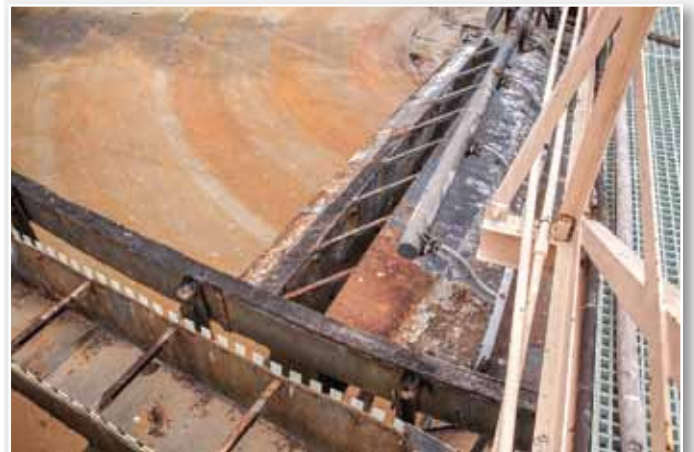
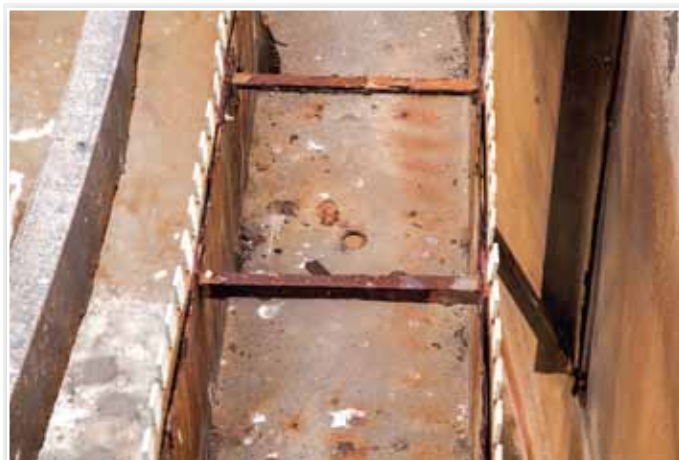
7. Primary Clarifiers:

Significant corrosion can be seen on the interior steel equipment of the clarifiers. The walkway has significant corrosion and for safety reasons workers use it sparingly. The majority of the primary clarifier equipment is in need of replacement.

Phased replacement of the primary clarifiers to meet reliability and performance requirements.

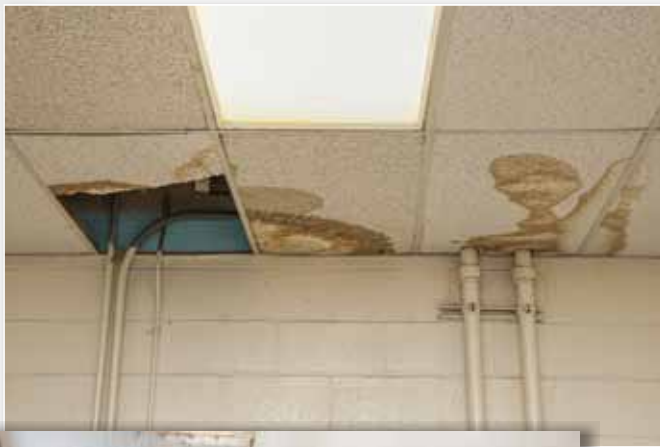
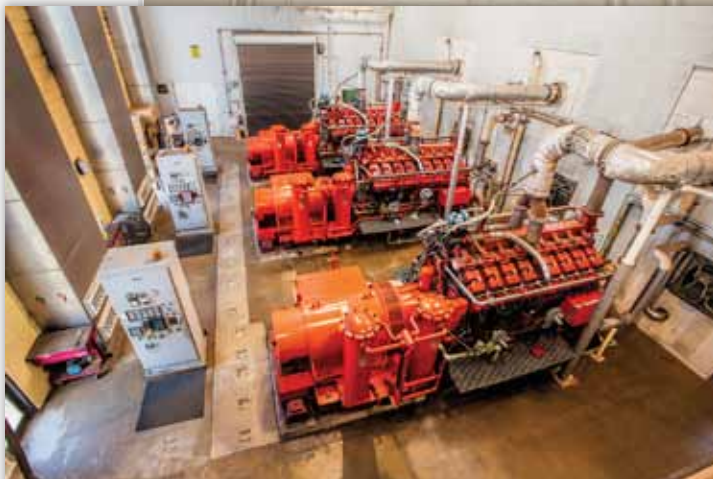
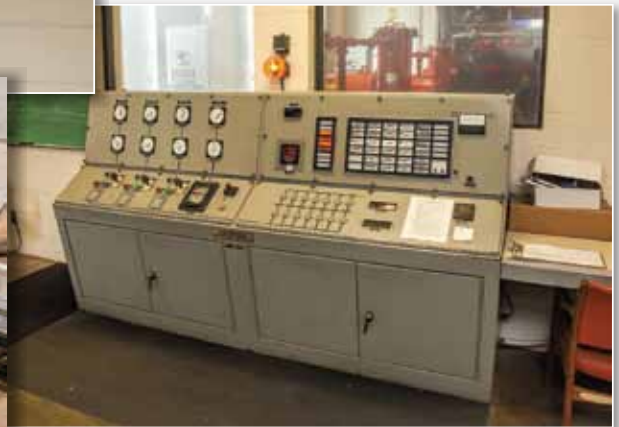
8. Cogeneration Facility:

The cogenerators are more than 25 years old and need to be rebuilt. The existing control system is outdated and the building roof leaks. The building also does not currently meet earthquake standards.

Rebuild cogenerators and upgrade control system to meet reliability and performance requirements. Replace the cogenerator building roof to address immediate concerns and plan to construct a new building in the future.
